**Invisible Metallic Microfiber in Clothing
Presents Unrecognized MRI Risk for
Cutaneous Burn**

TECHNICAL NOTE

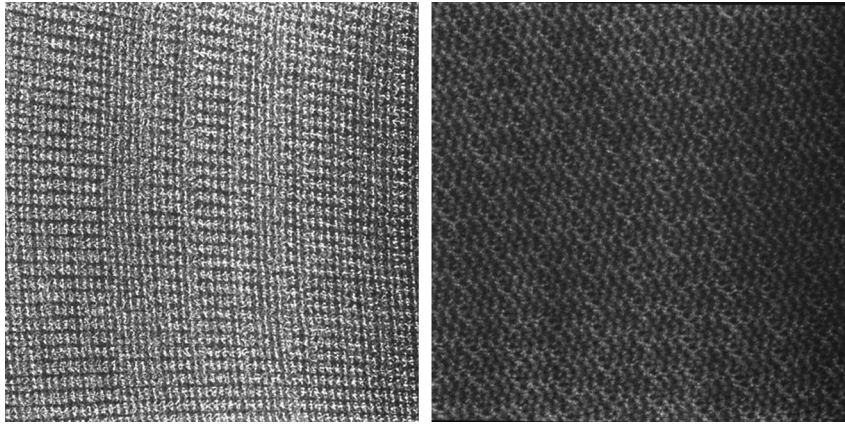
We suspect that our patient sustained cutaneous burns secondary to conductive SMF embedded in her undershirt. We retrospectively imaged the undershirt by high-resolution digital radiography (Fig 3) and demonstrated an interleaving weblike pattern of radiopaque SMF. We further demonstrated the enhanced electrical conductivity of the SMF fabric relative to control polyester and cotton fabrics by measuring the resistance by using a volt/ohm multimeter. The undershirt demonstrated low resistance (on the order of 10 ohms), which increased monotonically as a function of the distance separating the probes. In contrast, the resistance for both the cotton and polyester fabrics was infinite.

Fig 3. A digital radiograph demonstrating the metallic content of the fibers of the undershirt. Left image shows the radiopaque silver microwave fabric from the Boston Silver T. Comparison right image shows cotton fabric from a thermal undershirt.
