*AJNR Am J Neuroradiol* 1993, 14 (4) 892-895

# CT in Penetrating Craniocervical Injury by Wooden Foreign Bodies: Reminder of a Pitfall

**Summary:** The authors report three cases of penetrating craniocervical injury by wooden foreign bodies, which were initially hypodense on CT and thought to be air. When these structures were scrutinized with higher window settings, they had a higher attenuation and a unique striated internal architecture which the authors propose may be specific to wood.

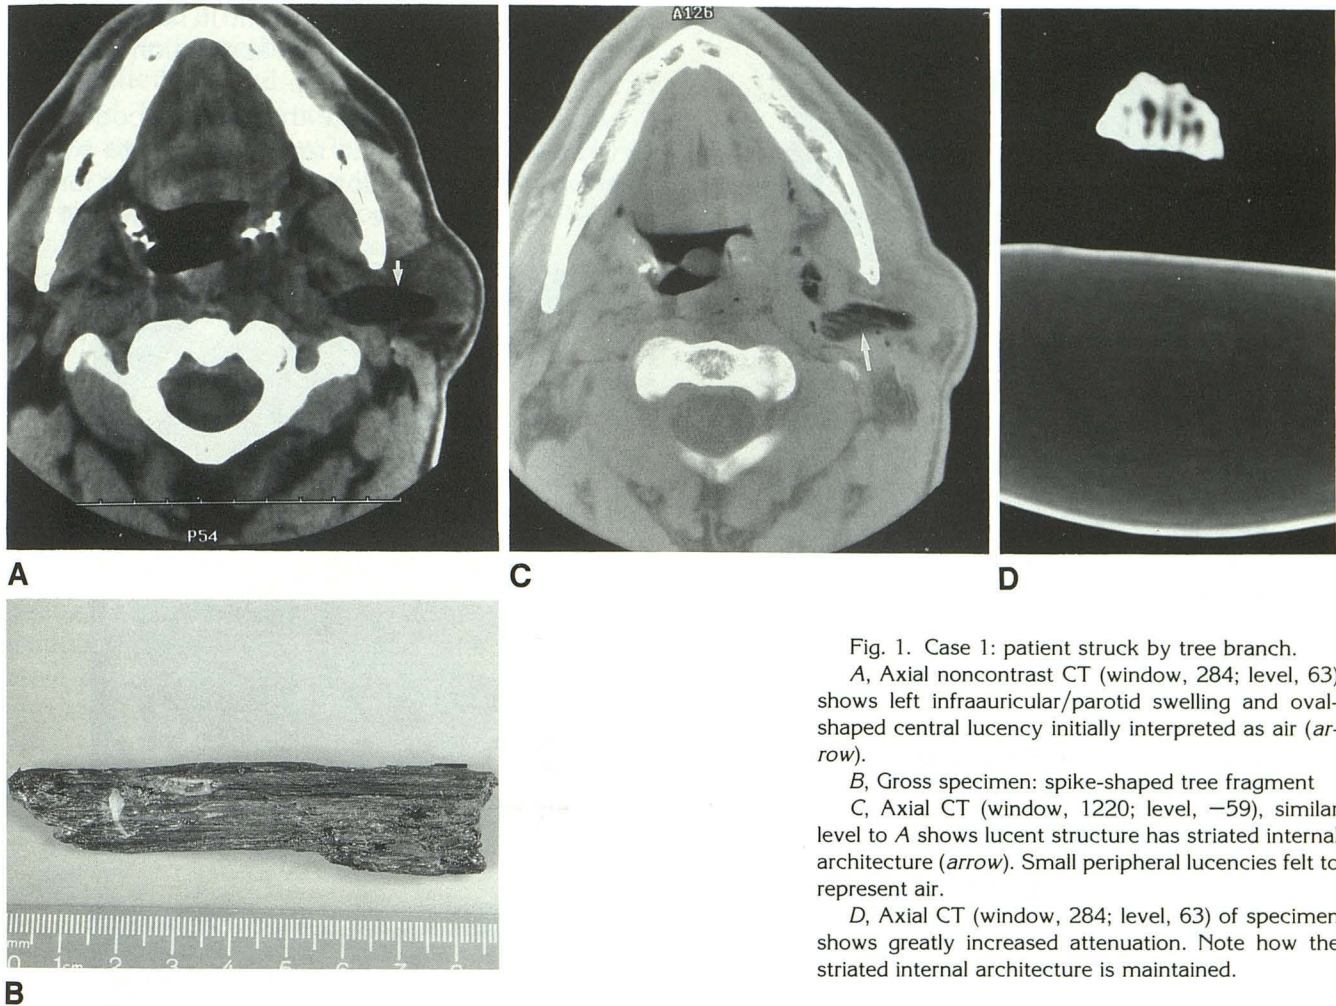
Fig. 1. Case 1: patient struck by tree branch.

A, Axial noncontrast CT (window, 284; level, 63) shows left infraauricular/parotid swelling and oval-shaped central lucency initially interpreted as air (*arrow*).

B, Gross specimen: spike-shaped tree fragment

C, Axial CT (window, 1220; level, -59), similar level to A shows lucent structure has striated internal architecture (*arrow*). Small peripheral lucencies felt to represent air.

D, Axial CT (window, 284; level, 63) of specimen shows greatly increased attenuation. Note how the striated internal architecture is maintained.

Over the course of several days, the patient continued to complain of dysphagia and odynophagia, and on the fourth hospital day, pus was expressed from the left ear laceration. Conservative measures and drainage failed to resolve the purulent discharge, and the patient stated “there’s something in there.” To exclude retained foreign body, the patient was explored 7 days after admission. An 8.5 × 1.5 cm spike-shaped piece of wood was discovered (Fig. 1B) at a point 2.5 cm deep to the auricular laceration and extending intermedially, ending posteromedial to the left carotid space at the level of the hyoid bone. The patient did well postoperatively. The initial CT exam was reviewed and the structure initially interpreted as air had an attenuation coefficient of –284 HU. Upon closer scrutiny after widening the window and decreasing the level, the structure no longer appeared homogeneously hypodense but instead clearly had a striated internal architecture, and was separable from adjacent air (Fig. 1C).

was imaged atop a water bath, it had a significantly higher density due to absorption of water or blood products (Fig. 1D).

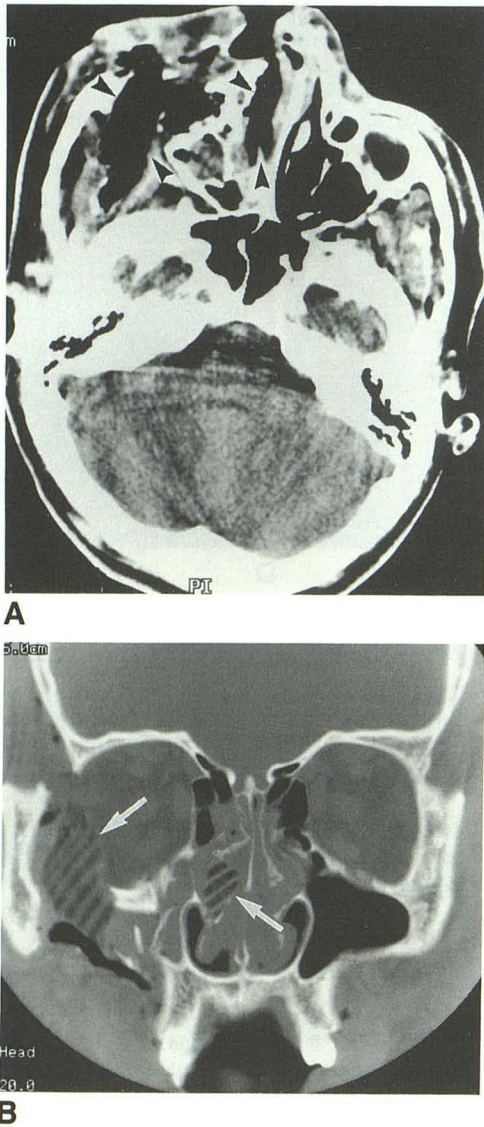
Fig. 2. Case 2: patient involved in motor-vehicle accident.

A, Axial noncontrast CT (window, 100; level, 40) shows disruption of the right maxillofacial region and what appears to be air in the right nasal cavity and right infratemporal fossa (*arrowheads*).

B, Coronal CT (window, 4178; level, 222) shows the structures in the right infratemporal fossa and right nasal cavity are not hypodense as air elsewhere but are higher density and possess a striated internal architecture (*arrows*). Wood fragments were recovered from both sites.

window images showed obvious bony disruption and what appeared to be air in the right infratemporal fossa (Fig. 2A). Bone windows demonstrated the facial fractures to better advantage, and showed that the low-density structures that mimicked air in the right nasal cavity and infratemporal fossa were not of appropriate attenuation for air but instead were higher density with a striated appearance (Fig. 2B). Surgical exploration yielded multiple wood fragments from these locations, the largest of which was  $4 \times 7 \times 2$  cm in dimension.

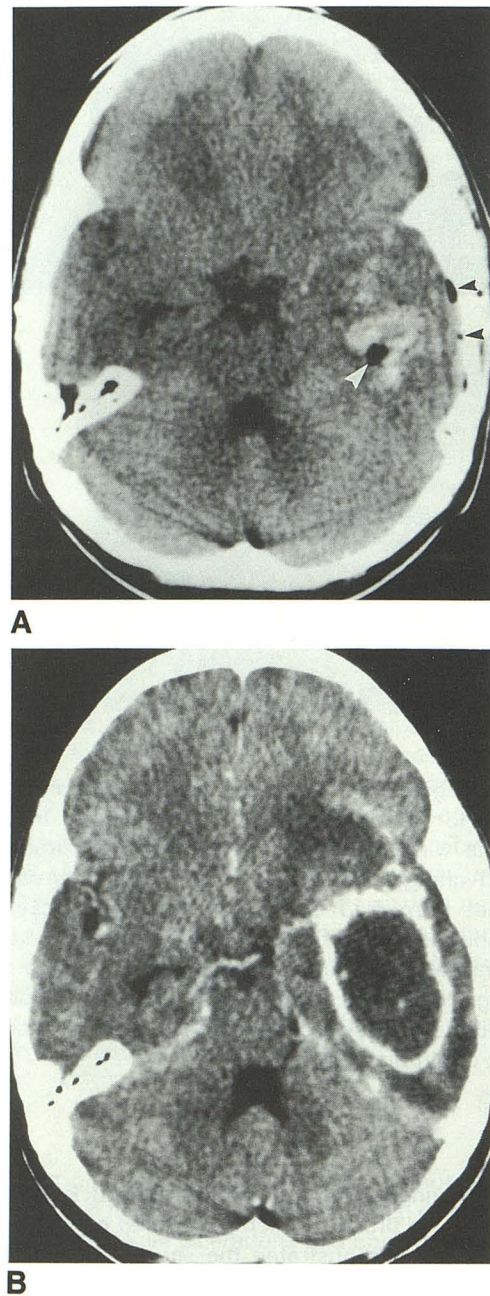
Fig. 3. Case 3: 13-year-old boy struck by tree branch.

A, Axial noncontrast CT (window, 100; level, 40) shows intracranial air near puncture site laterally (*black arrowheads*). Within temporal lobe hemorrhagic contusion, hypodense structure proved to be a wood fragment (*white arrowhead*).

B, Axial postcontrast CT (window, 100; level, 40) shows rim-enhancing left temporal lobe abscess.

While playing, a 13-year-old boy was struck on the head by a falling tree branch, which penetrated his left temporal squamosa. CT demonstrated the site of bone disruption, and soft-tissue windows showed intracranial air as well as hemorrhagic contusion in the left temporal lobe (Fig. 3A). However, on bone windows (not shown), the largest "air" pocket was actually higher in attenuation than air. Upon evacuation of the parenchymal hematoma, a small fragment of wood was removed. Despite surgical removal of this foreign body, the patient subsequently developed a mixed fungal and bacterial abscess within the surgical bed

(Fig. 3B). With further surgical intervention and antifungal and antibacterial therapy, the patient ultimately recovered.
